United States Department of the Interior
National Park ServiceNational Register of Historic Places
Registration Form

other names/site number Robidoux Hill Historic District

street & number 502-924 N. 6th St., 503-724 N. 5th St. (See cont. sheet) ☐ not for publicationcity, town St. Joseph ☐ vicinity

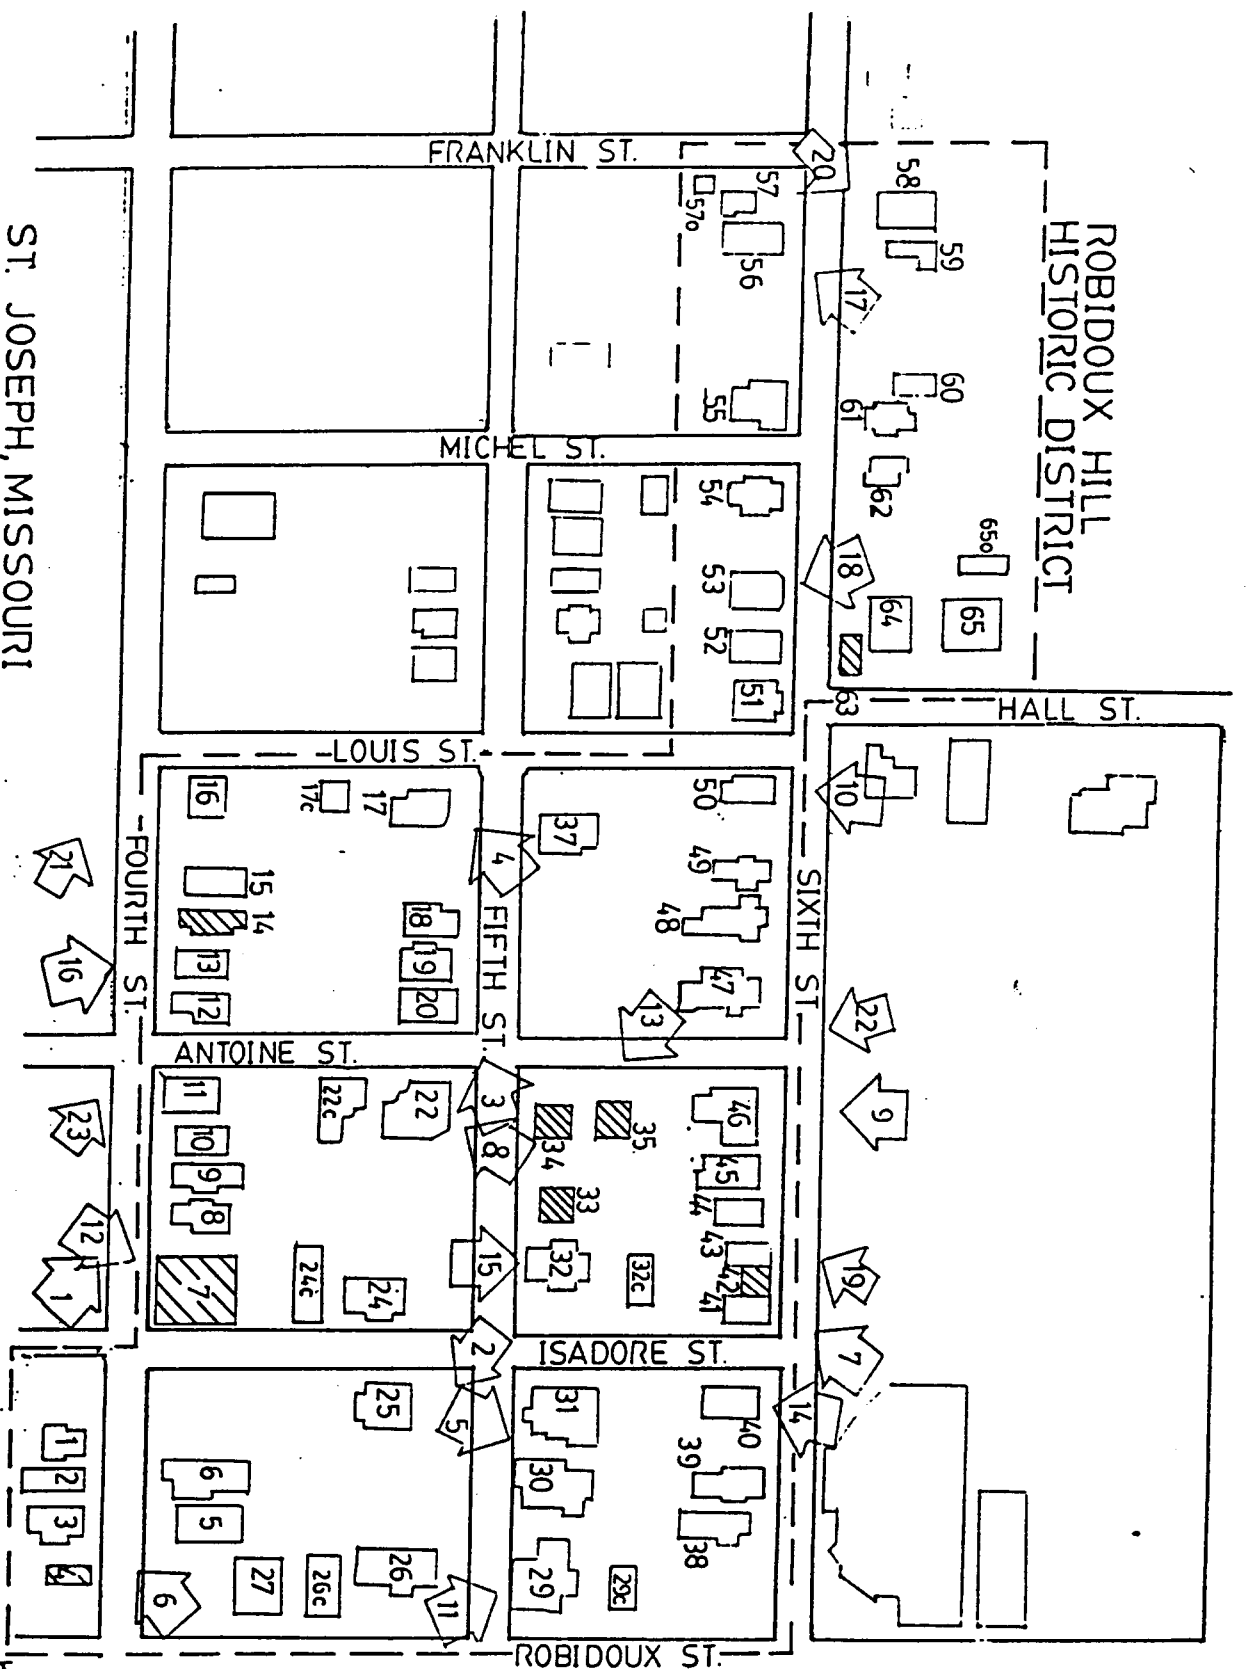
boundary

◀ NORTH
 ▨ noncontributing

The resources of the Robidoux Hill Historic District have been assigned map reference numbers to show the mapped location of the properties comprising the district. The numbers used for this purpose correspond to a numbering system used to identify the district's resources when originally surveyed. Since the original survey, building #36 has been demolished; numbers #21, #23 and #28, originally assigned to identify outbuildings functionally and historically related to residences, have been deleted from the district map and are not used to identify properties in the nomination. With deletion of these four map numbers the district count stands at 69 total resources including: 53 residences, 8 carriage barns or associated outbuildings, and 8 noncontributing buildings; a total of 61 contributing buildings add to the historic character of the district.
